Status of Hamaoka Nuclear Power Station Units Nos. 1, 2 and 5

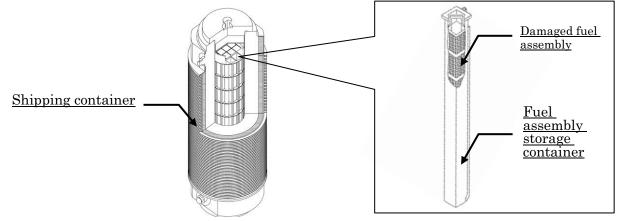
Figure 1 Diagram of fuel assembly storage container and shipping container holding damaged fuel assembly

The damaged fuel assembly being stored in Unit No. 1 will be loaded into a shipping container fitted with a fuel assembly storage container (see Figure 1), and will be shipped to Unit No. 5 for storage in the Unit No. 5 fuel storage pool.

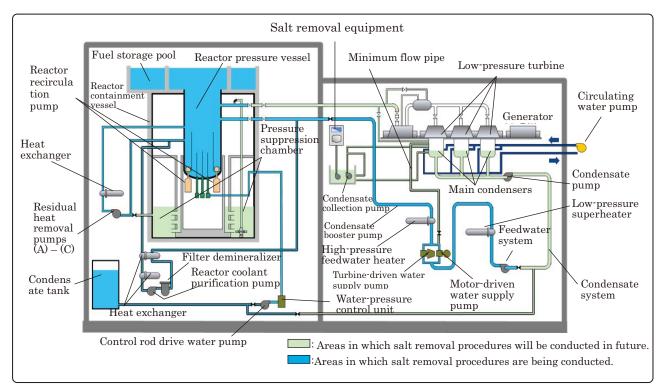
Figure 3 Status of progress of salt removal procedures

On May 14, 2011, damage to the main condenser tubes of Unit No. 5 during the process of achieving cold shutdown following shutdown of the reactor resulted in the infiltration of seawater into the reactor systems, and we are therefore conducting salt removal procedures and inspecting and evaluating the equipment and the fuel.

With regard to equipment other than the above, immediately following the infiltration of the seawater, we commenced salt removal procedures in sequence, and we are progressively examining pumps and heat exchangers in systems as we complete the salt removal. Up to the present, the results of disassembly inspections of equipment including the control rod drive water pumps, the residual heat removal pumps, and heat exchangers and valves in the reactor's systems have shown overall a higher amount of adhesion of foreign matter and rust than was the case in previous inspections, but the level is such that it will be able to be removed during the cleaning process. In the case of equipment including the condensate collection pump outlet pipes, the adhesion of salt has resulted in corrosion in certain places, and we are currently examining the cause and formulating measures to respond.
